# THE CURRENT TECHNOLOGICAL FRONTIERS OF THE DEVELOPMENT OF SOUR SERVICE HEAVY PLATES

**Gerdau Ouro Branco**

October 2018

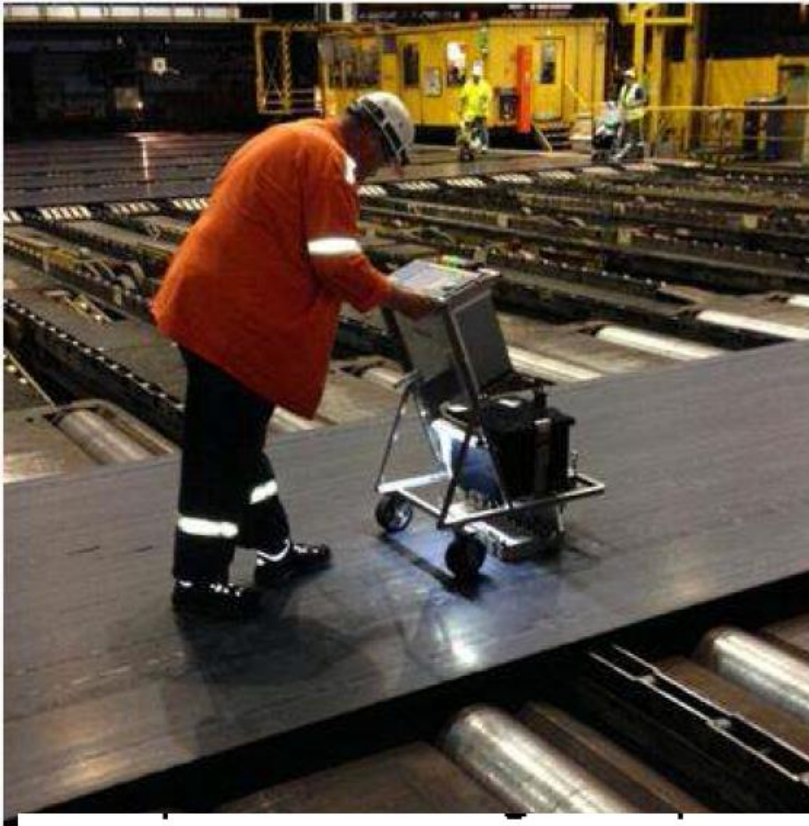
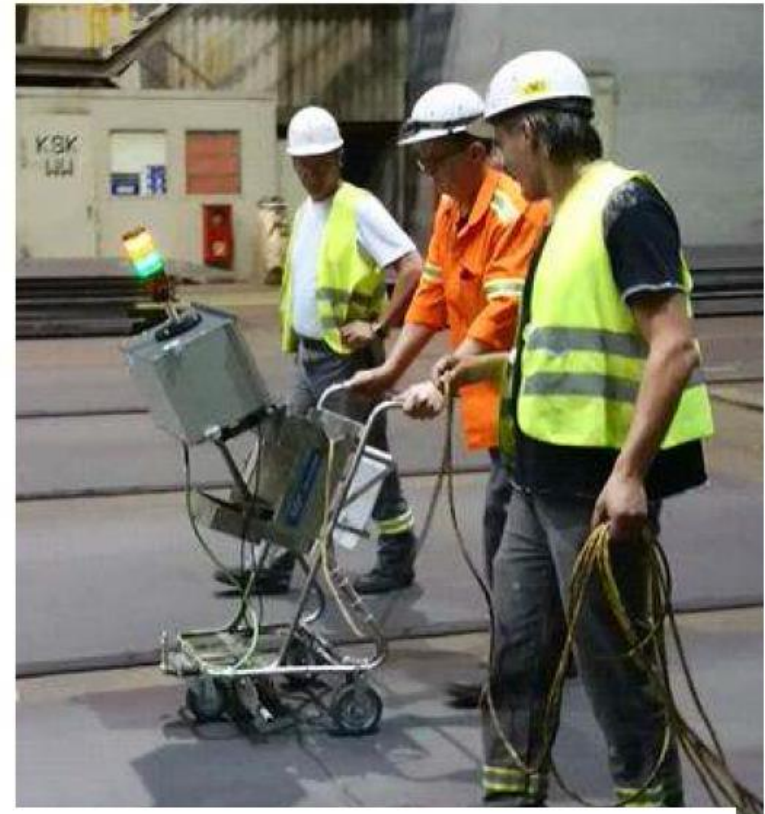
It is the so-called D-TECTor: Dillinger – Totally Eddy Current Detector, which determines **maps of plate hardness** using a magnetic test based on eddy currents.

Dillinger steelworks in Germany has developed a **non-destructive method** for the **massive** and **high resolution** measurement of hardness in rolling stocks, in a manner rather analogous to what is already done in the plate ultrasound analysis of internal soundness.
